**MORGANZA TO THE GULF
FEASIBILITY STUDY: CULTURAL RESOURCES
SAMPLE SURVEY, TERREBONNE AND
LAFOURCHE PARISHES, LOUISIANA**

VOLUME II OF II

**FINAL REPORT
NOVEMBER, 2000**

Phase I Cultural Resources Sample Survey of the Proposed Morganza to the Gulf Feasibility Study, Terrebonne and Lafourche Parishes, Louisiana (Volume II of II)

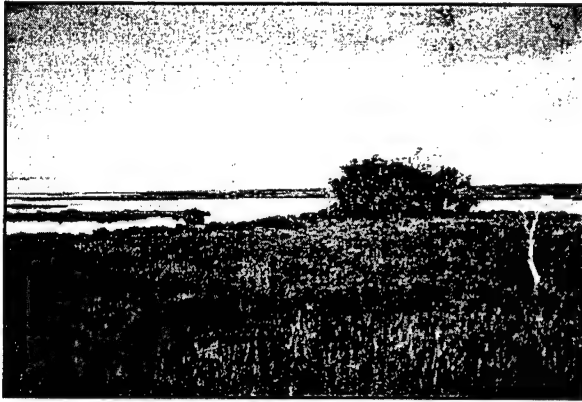
Figure 60. An overview of Site 16TR33 facing west.

With the exception of the depression mentioned above, the mound structure at Site 16TR33 is in good condition. Although no cultural material was recovered as a result of the current in-

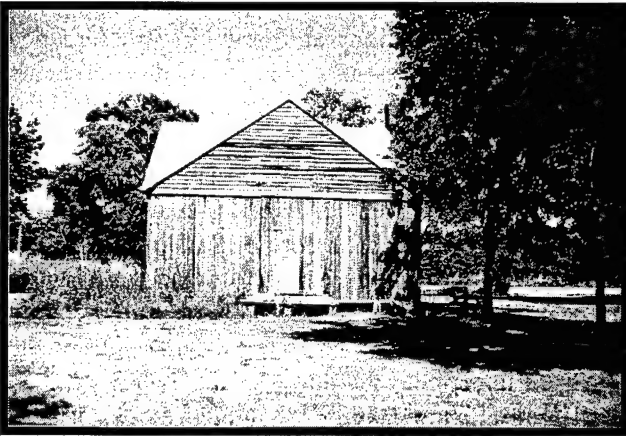
Figure 72. An overview of the rear (eastern) elevation of Standing Structure 55-1113. Note the cross gable, the horizontally oriented planks along the exterior wall, the vertically oriented planks along the gable, the back door, the back porch, and the supporting piers.

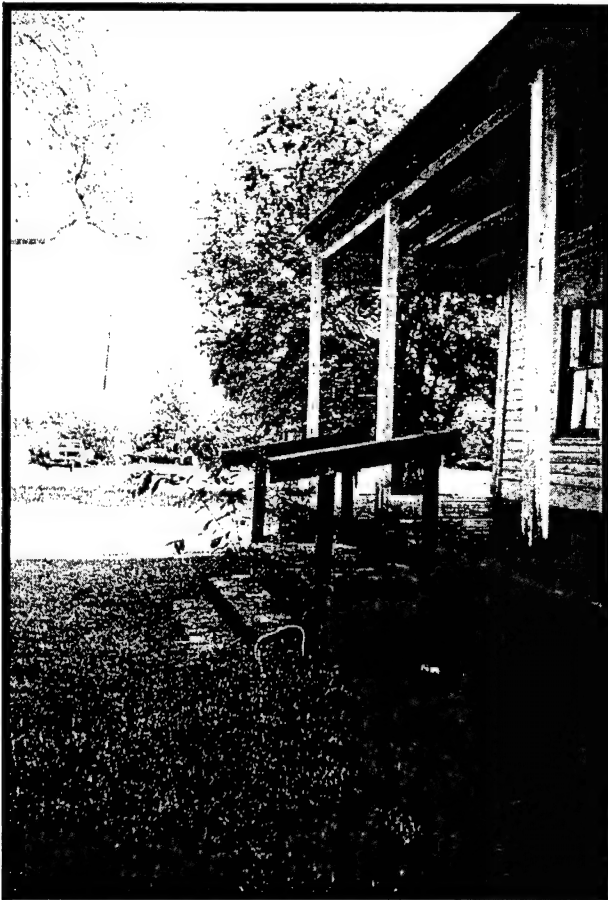
Figure 78. A detail of the squared wooden columns, the wooden steps, and the railing on the front porch at Standing Structure 55-1113.

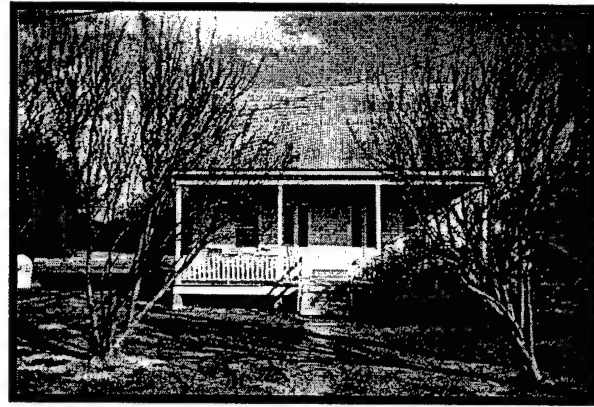
Figure 98. An overview of the front (western) elevation of Standing Structure 55-1011. Note the horizontally oriented wood siding, the front porch, the squared wooden porch supports, the porch banister, the double French doors, and the corrugated metal roof.

In summary, Standing Structure 55-1011 consists of a mid-nineteenth century, National style, massed plan, side-gabled (Acadian salt box) dwelling. Although it is a well maintained building, the original fabric of the dwelling has been compromised by the addition of a rear wing, the replacement of the original steps and structural supports, the addition of aluminum siding, and the removal of the original chimney. These results suggest that Standing Structure 55-1011 no longer possess integrity of materials,

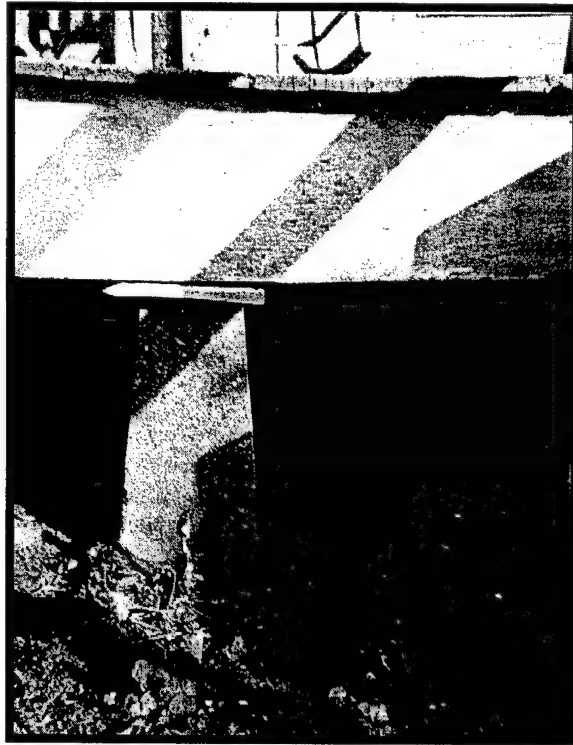
Figure 103. A detail of the masonry (concrete) piers identified at Standing Structure 55-1011.

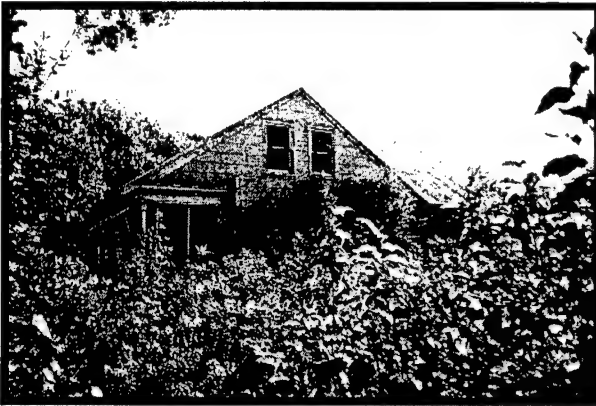
Figure 110. A partially obscured overview of the front (western) elevation of Standing Structure 55-1012. Note the inset front porch under the principal roof, the awning along the front porch, the corrugated metal roof, and the vegetation that has grown around the structure.
